DEPARTMENT OF TRANSPORTATION**DIVISION OF ENGINEERING SERVICES**

Contract #: 04-0120F4Cty: SF/ALA Rte: 80 PM: 13.2/13.9File #: 1.28**WELDING INSPECTION REPORT****Resident Engineer:** Casey, William**Address:** 333 Burma Road**City:** Oakland, CA 94607**Report No:** WIR-029067**Date Inspected:** 04-Feb-2013**Project Name:** SAS Superstructure**OSM Arrival Time:** 700**Prime Contractor:** American Bridge/Fluor Enterprises, a JV**OSM Departure Time:** 1730**Contractor:** American Bridge/Fluor Enterprises, a JV**Location:** Job Site**CWI Name:** As noted below**CWI Present:** Yes No**Inspected CWI report:** Yes No N/A**Rod Oven in Use:** Yes No N/A**Electrode to specification:** Yes No N/A**Weld Procedures Followed:** Yes No N/A**Qualified Welders:** Yes No N/A**Verified Joint Fit-up:** Yes No N/A**Approved Drawings:** Yes No N/A**Approved WPS:** Yes No N/A**Delayed / Cancelled:** Yes No N/A**Bridge No:** 34-0006**Component:** SAS OBG**Summary of Items Observed:**

WELDING INSPECTION REPORT

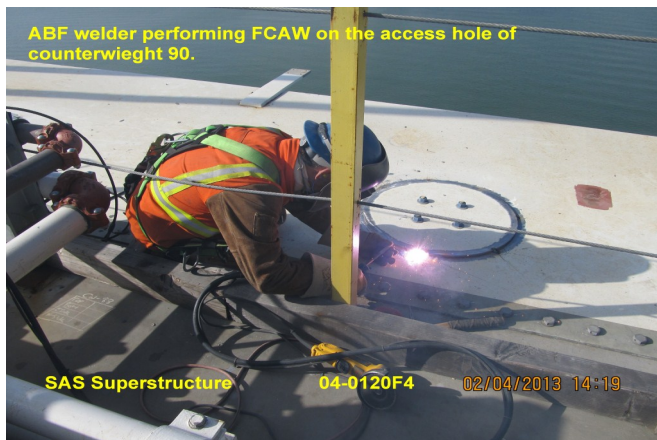
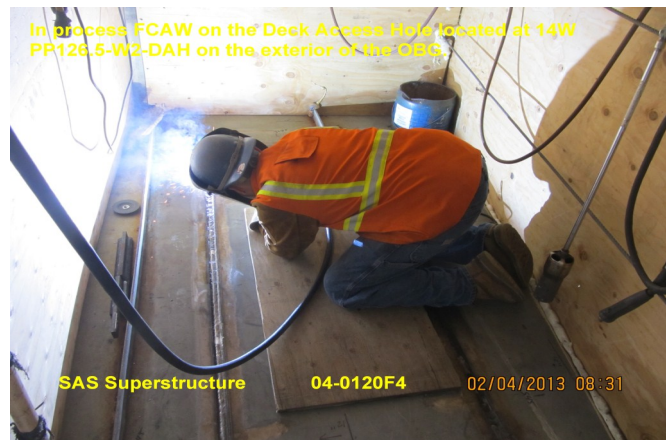
ABF welder Wai Kit Lai #2953 was observed performing SMAW welding on the Deck Access Hole at 14E PP126.5-E2-DAH. The welder was observed utilizing WPS ABF-D1.5-1040C-CU for SMAW. The welder was observed preheating the welds prior to welding. Other welding parameters as inspected by the QC Inspector appeared to be in compliance with the WPS noted above. Work is in progress on the interior side of the plate.

ABF welder Richard Garcia #5892 was observed performing FCAW welding on the Deck Access Hole at 14W PP126.5-W2-DAH. The welder was observed utilizing WPS ABF-D1.5-3040A-1 for FCAW. The welder was observed preheating the welds prior to welding. Other welding parameters as inspected by the QC Inspector appeared to be in compliance with the WPS noted above. The work is in progress.
